Valenti Classic Cars, Inc.  
Caledonia, WI

## DISASTER RESTORATION, FIRE

Valenti Classic Cars, Inc., known for their iconic Corvette on the roof, is a classic, antique, and muscle car dealer and auto body. After a devastating fire in the shop, their operation was forced to temporarily close for extensive repairs resulting from fire, smoke, soot and water damage.

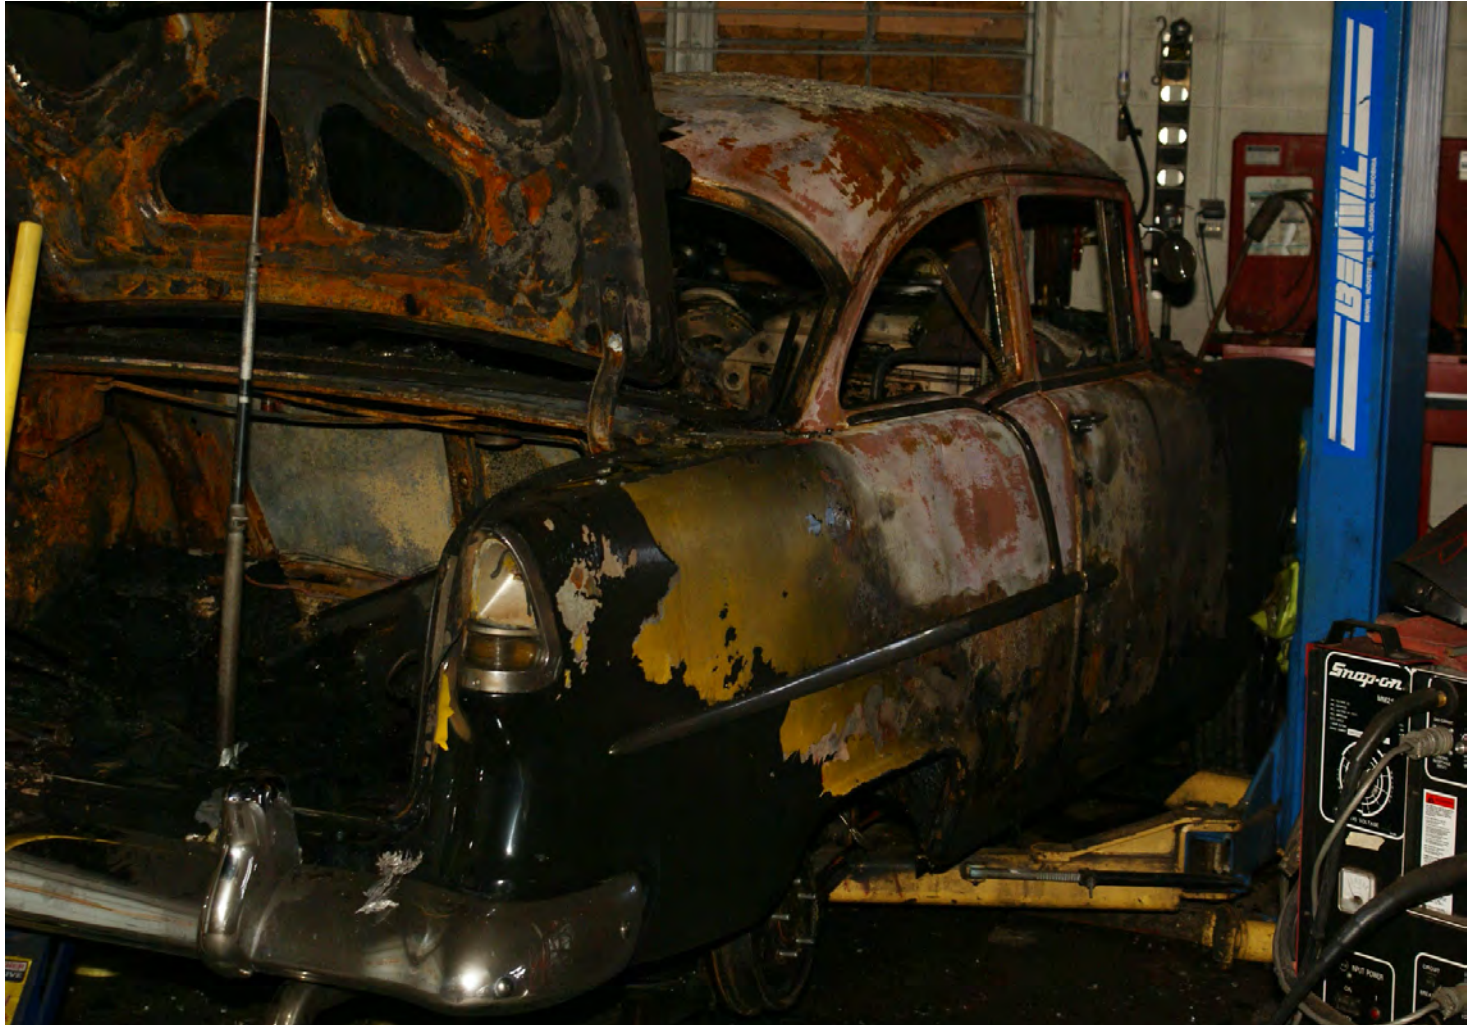
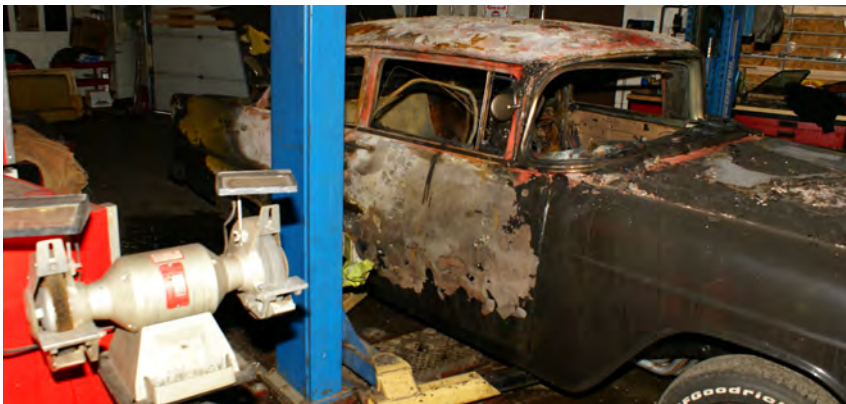
## *The Damage:*

An early evening fire ripped through the vintage Valenti Classic Car Body Shop. A 1955 Chevrolet model 210 raised on a lift burned and caused damage in the northwest corner of the shop. Fortunately, the extent of the structural damage was contained to the 1000 sq/ft shop.

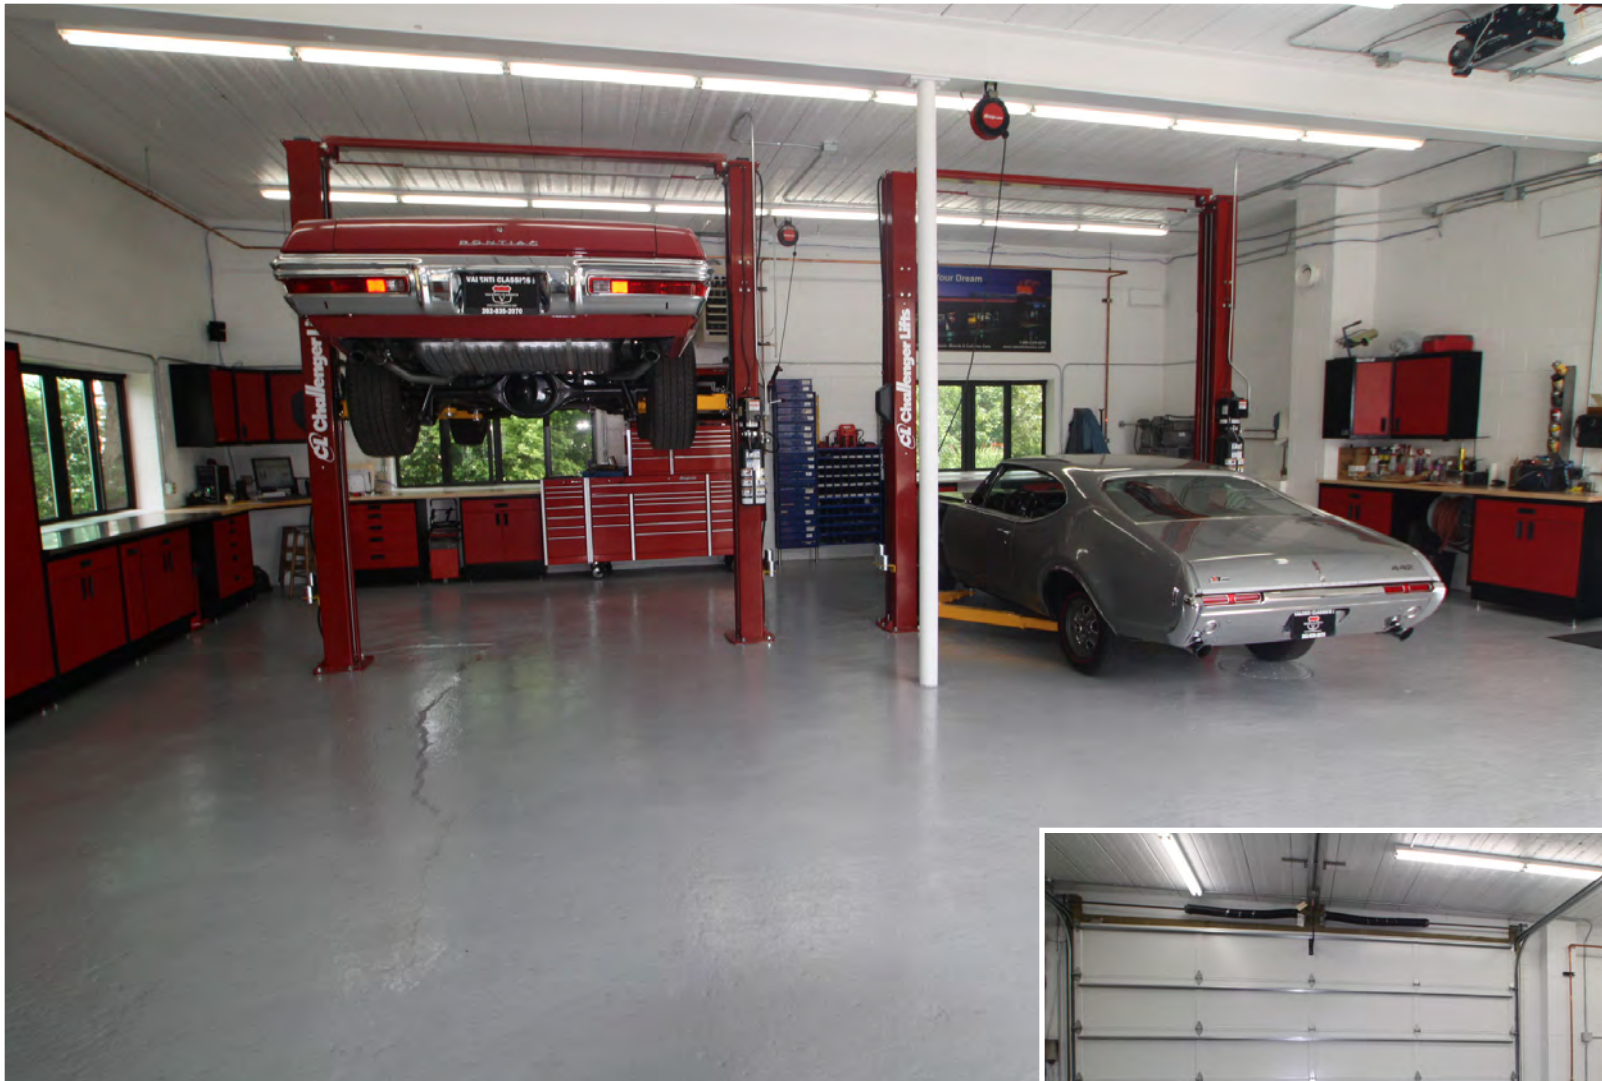
The owner wished to create an environment with better flow so cars could enter and leave the shop floor without disrupting other work stations. An additional wish was for modern lifts that offered greater flexibility and safety mechanisms.

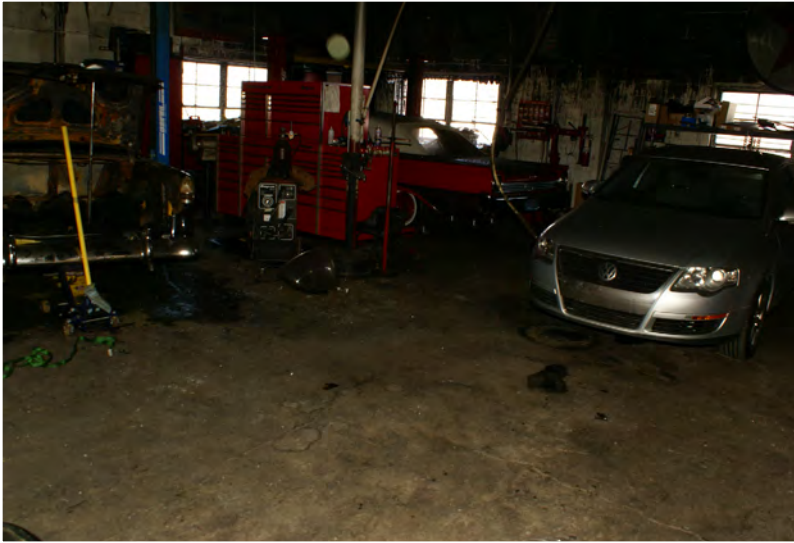
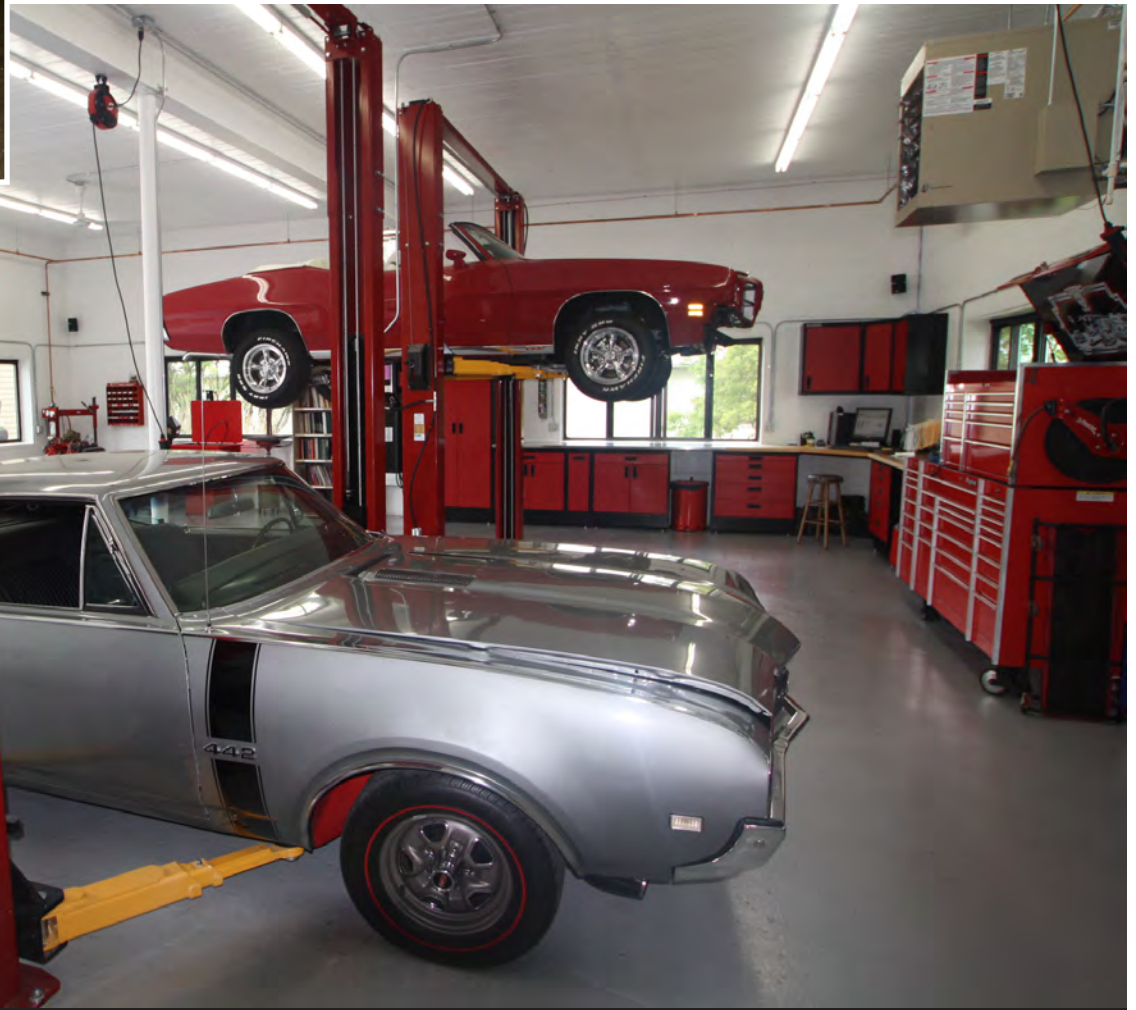
### *The Challenge:*

PVC tubing for airlines ran the perimeter of the shop and presented code and safety concerns for employees and patrons.

### *The Solution:*

PVC tubing was replaced by copper lines throughout the shop allowing for controlled and safe air pressure.

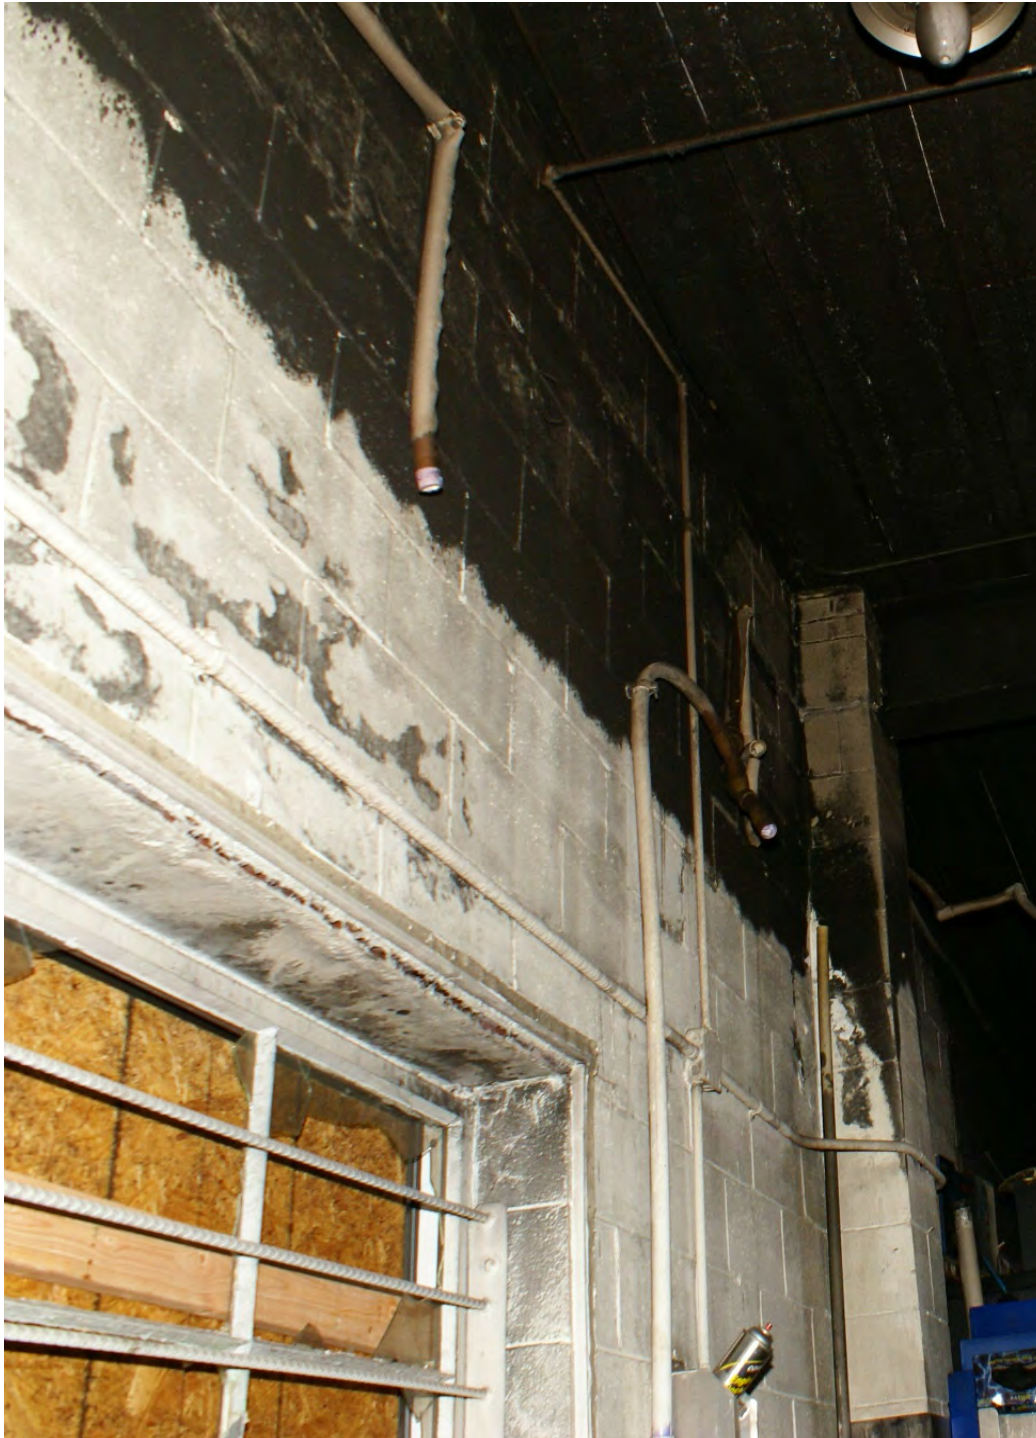
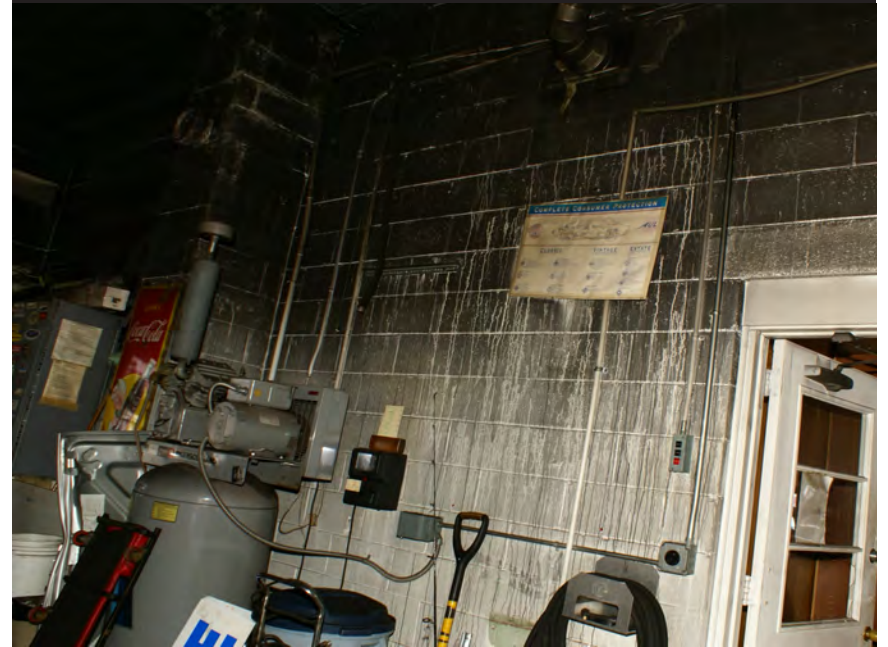
### ***The Challenge:***

No surface was untouched from the ceiling to the floor. Intense scorch marks, dark soot and extensive heat damage devastated the shop. Note the intense and visually graphic heatline around the perimeter of the facility.

### ***The Solution:***

Special attention was paid to all surfaces. The block walls and structural concrete panel ceilings were cryo blasted and then went through a rigorous power washing. All hard surfaces were refinished.

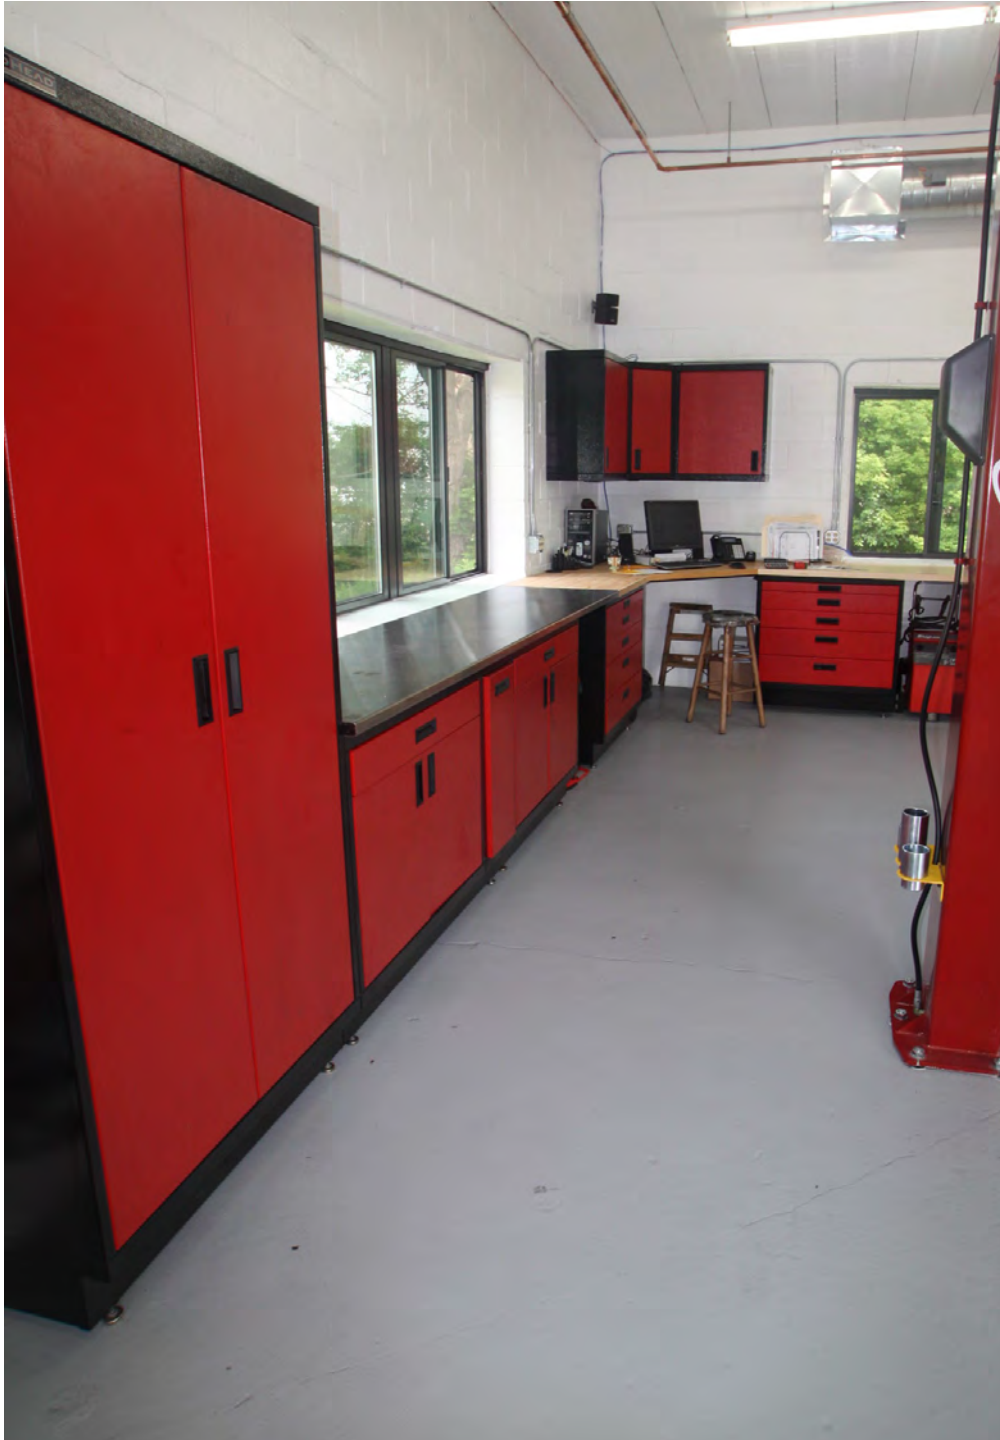
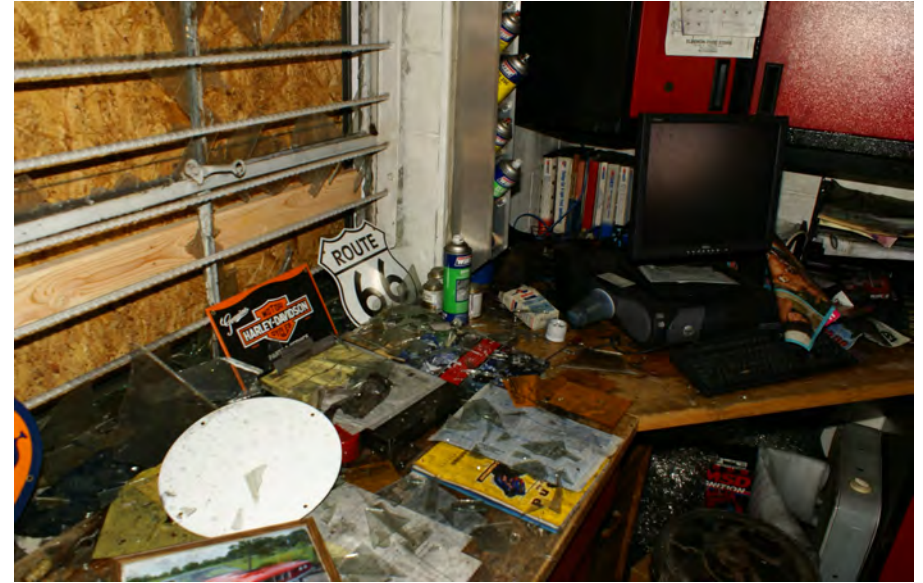
### ***The Challenge:***

Many windows were broken or badly damaged by the heat. The 1960's structure and original windows had asbestos in the glazing. Furthermore, functionality simply was not there because the windows did not open, making the shop conditions uncomfortable to employees.

### ***The Solution:***

Security bars were unsightly and unnecessary so were removed and not replaced. Insurance dollars were reallocated by eliminating the bars and placed towards upgrading the windows. The windows are now operable and offer a refreshing cross breeze in addition to increased energy efficiency.

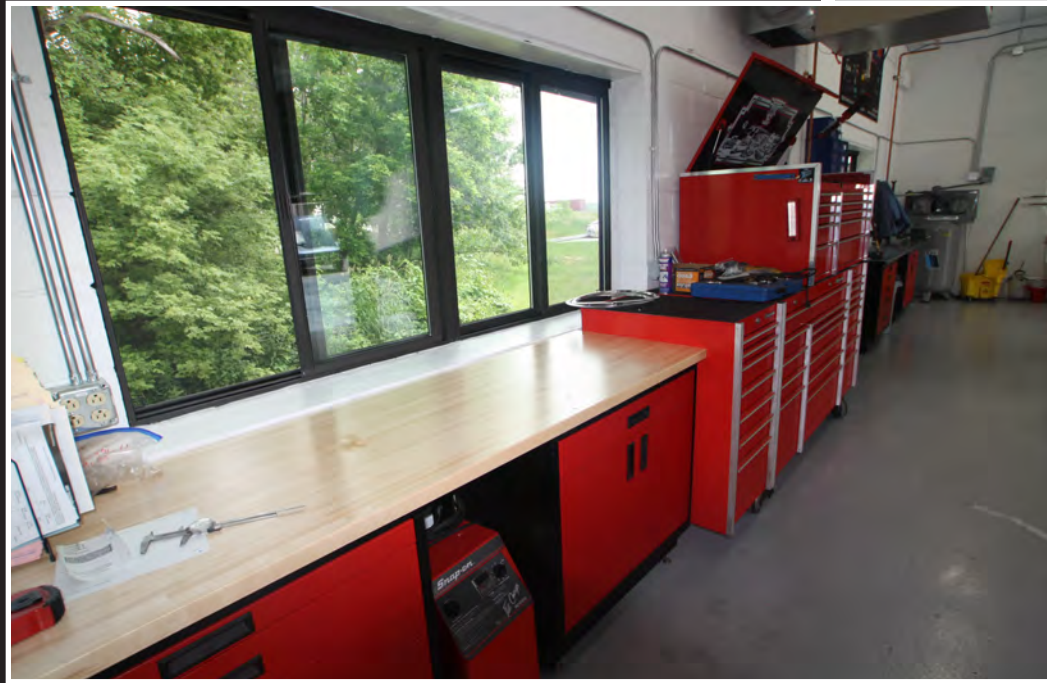
### ***The Finishes:***

Stainless steel counters withstood the the water, heat and fire damage. The wood finishes did not withstand the extreme elements. Thirty-two feet of butcher-block was replaced. Notice how the contrast of metal and wood add visual interest to the shop, yet boosts strong functionality and durability for the mechanics.

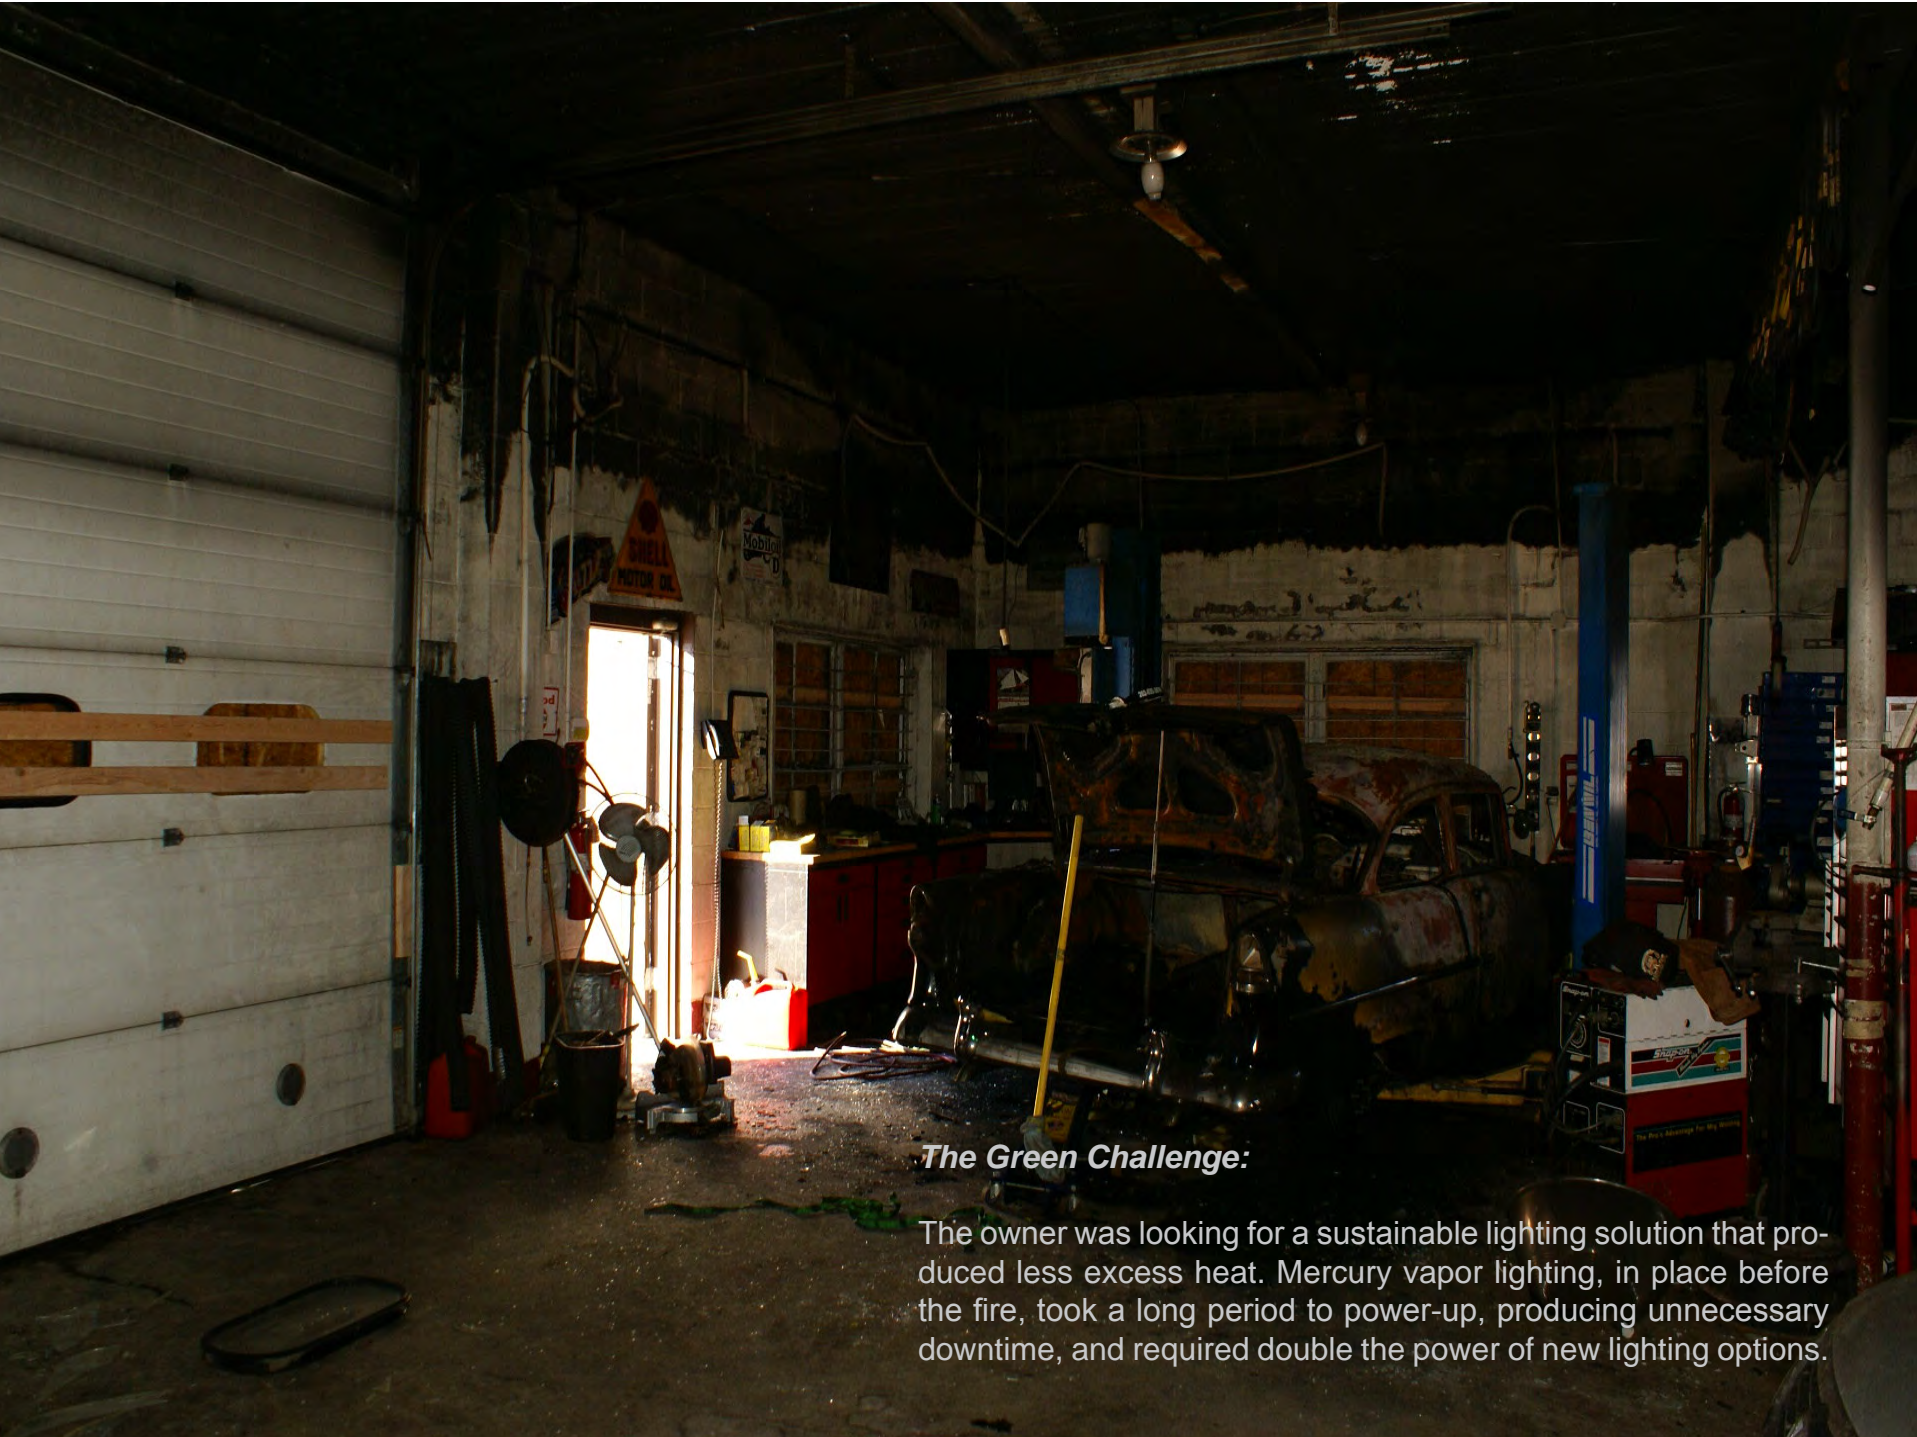
***The Green Challenge:***

The owner was looking for a sustainable lighting solution that produced less excess heat. Mercury vapor lighting, in place before the fire, took a long period to power-up, producing unnecessary downtime, and required double the power of new lighting options.

*The Green Solution:*

Energy efficient fixtures were installed both meeting the lighting needs of the auto shop staff and offering the desired sense of sustainability the owner was seeking.

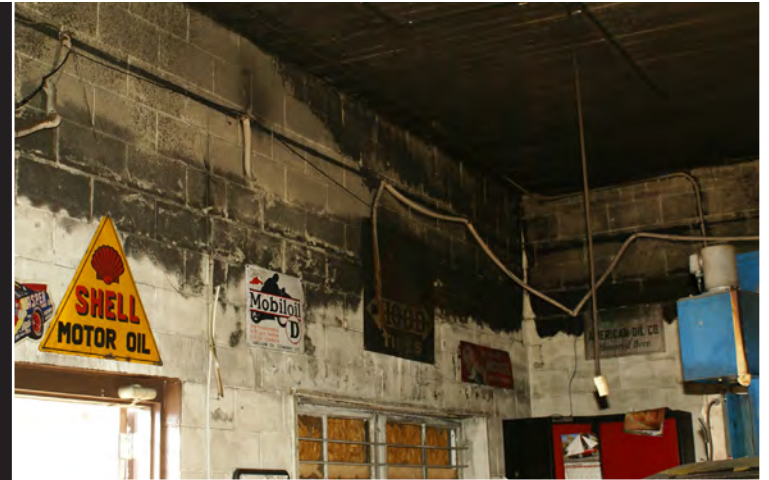
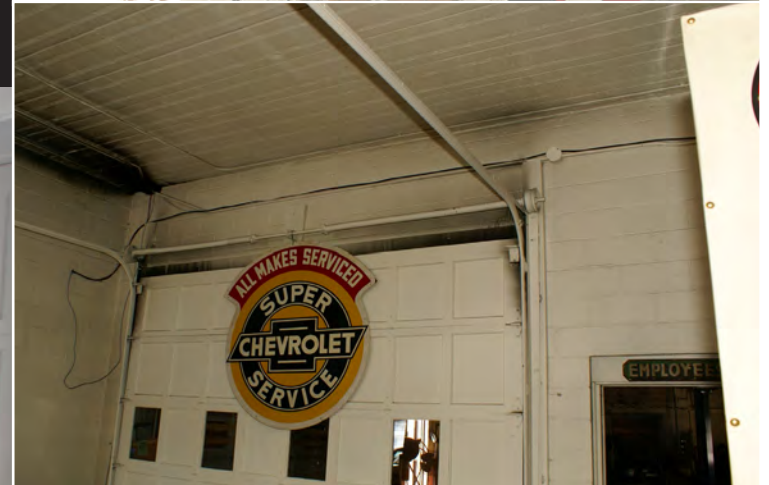
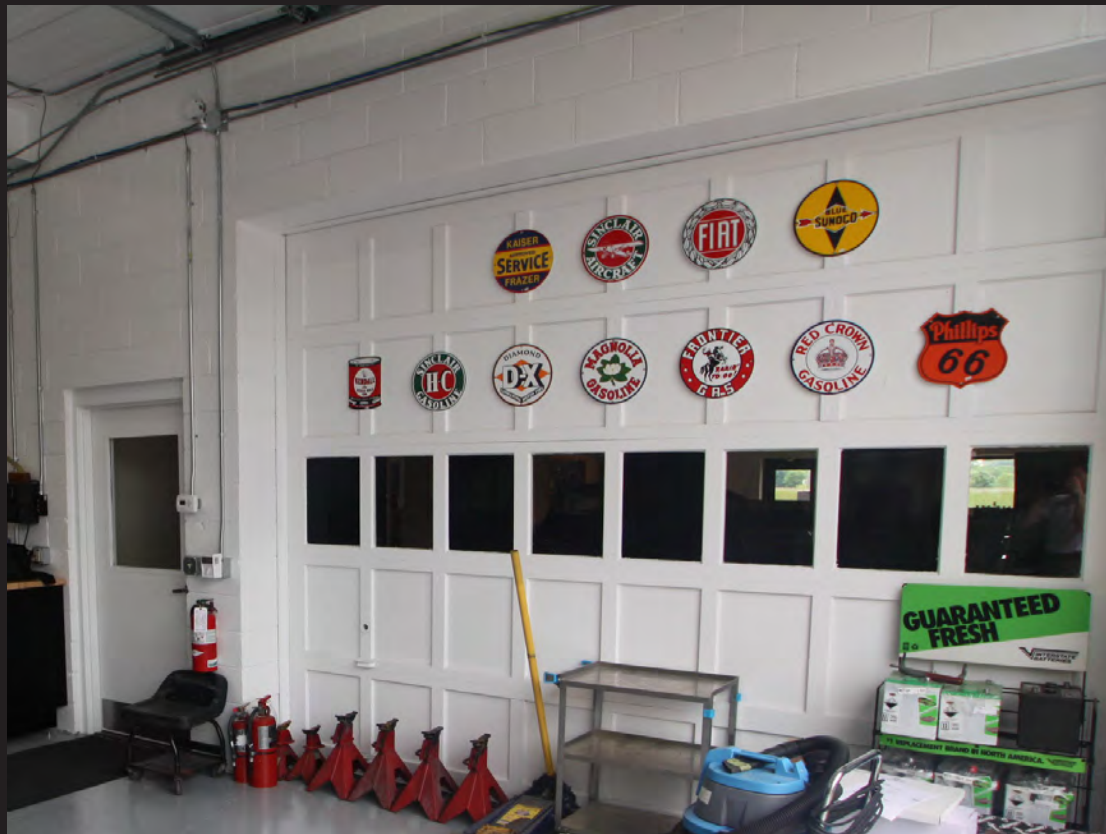
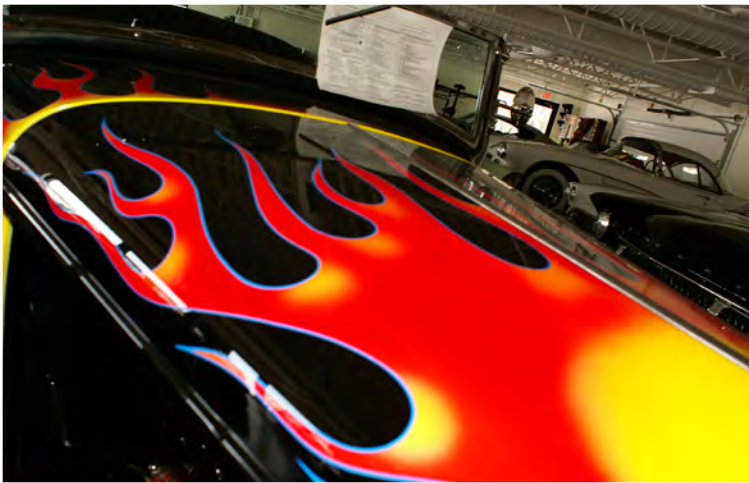
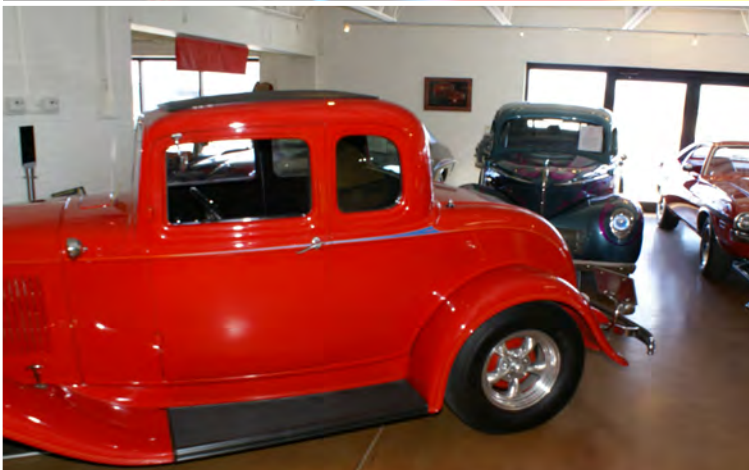
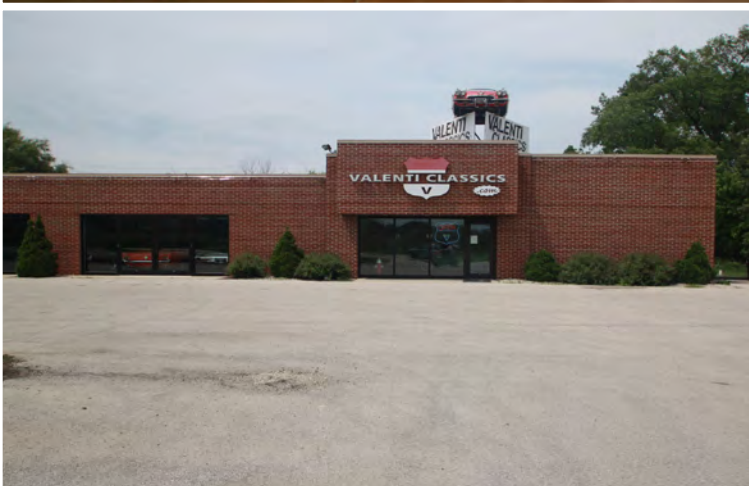
### *The Challenge:*

Valuable vintage and antique signs, collected over many years, were important to the Valenti family. The fire damaged all surfaces and aesthetically compromised the metal and ceramic signs around the heat-line.

### *The Solution:*

Many of the owner's collectible pieces were successfully restored to pre-loss condition and are again proudly displayed throughout the vintage building.

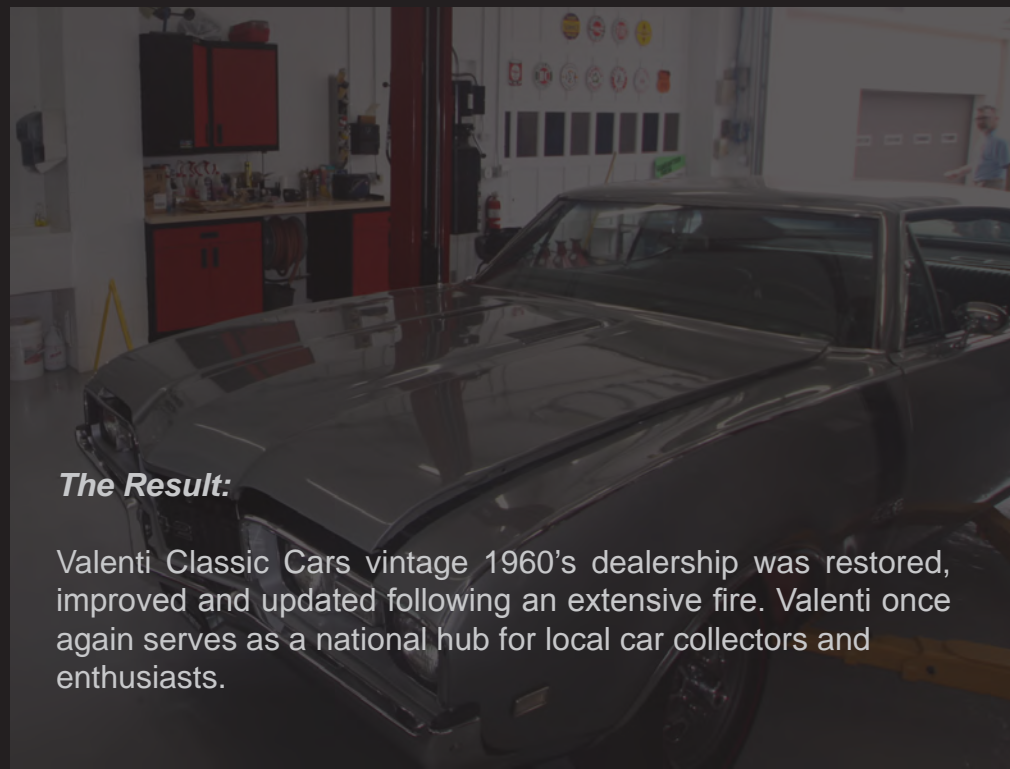
Thirty collectible cars were parked on the sales floor at the time of the fire. The cars and all other surfaces were covered with a fine black soot and a fire odor was present.

This section of the building required detailed restoration and cleaning. The sales floor also received a soft facelift. Dark paneling was painted white to refresh and update the space. Additionally, flooring was upgraded from pergo to a VCT commercial tile, a much more practical surface for automobile tires.

Valenti Classic Cars vintage 1960's dealership was restored, improved and updated following an extensive fire. Valenti once again serves as a national hub for local car collectors and enthusiasts.
